SOLAR COLLECTOR TEST REPORT

A Report to:	Renewable Energy Inc. 6 Cornell Ln. Little Neck, NY 11363 USA
Attention:	Richard Wu, Marketing Director
Telephone:	718-690-2691
Fax:	718-225-4371
E-mail:	wu2816@gmail.com
Report No.:	08-08-0173-A 6 Pages, 1 Appendix
Proposal No.:	08-008-5838RV3
Date:	August 31, 2009

This report is the second report prepared to describe testing performed by Exova (formerly Bodycote Testing Group) of one solar hot water heater system in accordance with specified sections of the SRCC Standard 100-08 for **Renewable Energy Inc.**

This report covers only the testing in accordance with the SRCC Standard 100-08 Section 5.7 *Second Static Pressure Leakage Test*. This was the second post-exposure pressure test on the system described in Section 2.0 below. This second post-exposure pressure test was performed because this test sample failed the first post-exposure pressure test. This report should be read in conjunction with Bodycote Testing Group Report No. 08-08-0173 dated June 30, 2009, for a full description of the tests that this test sample had undergone prior to the tests described in this current report.

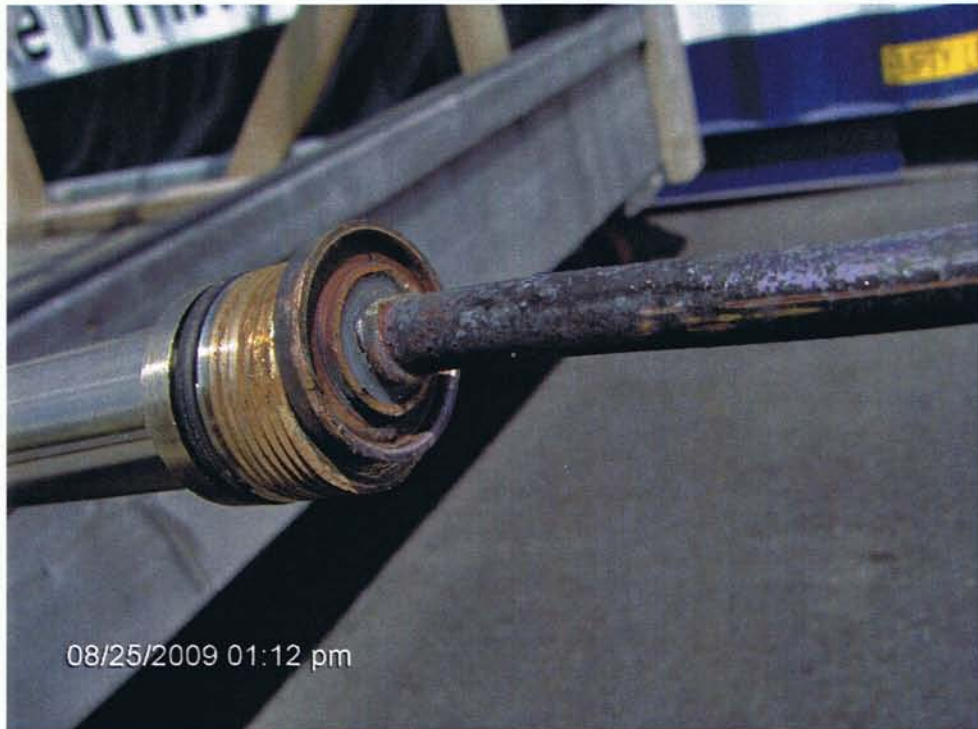
The third evacuated tube from the East end of the collector was removed, and the heat pipe was then unscrewed from the tank. The O-ring was then removed using a small flat spatula. The O-ring was stuck to the metal seal on the tank, and was damaged by the removal process. The O-ring removed from the tank showed evidence of permanent deformation (flattening), and discoloration compared to a new O-ring. A photograph of the end of the heat pipe showing the O-ring seal seat is shown in figure 1.

Figure 1: The condenser end of the heat pipe showing the O-ring seal seat

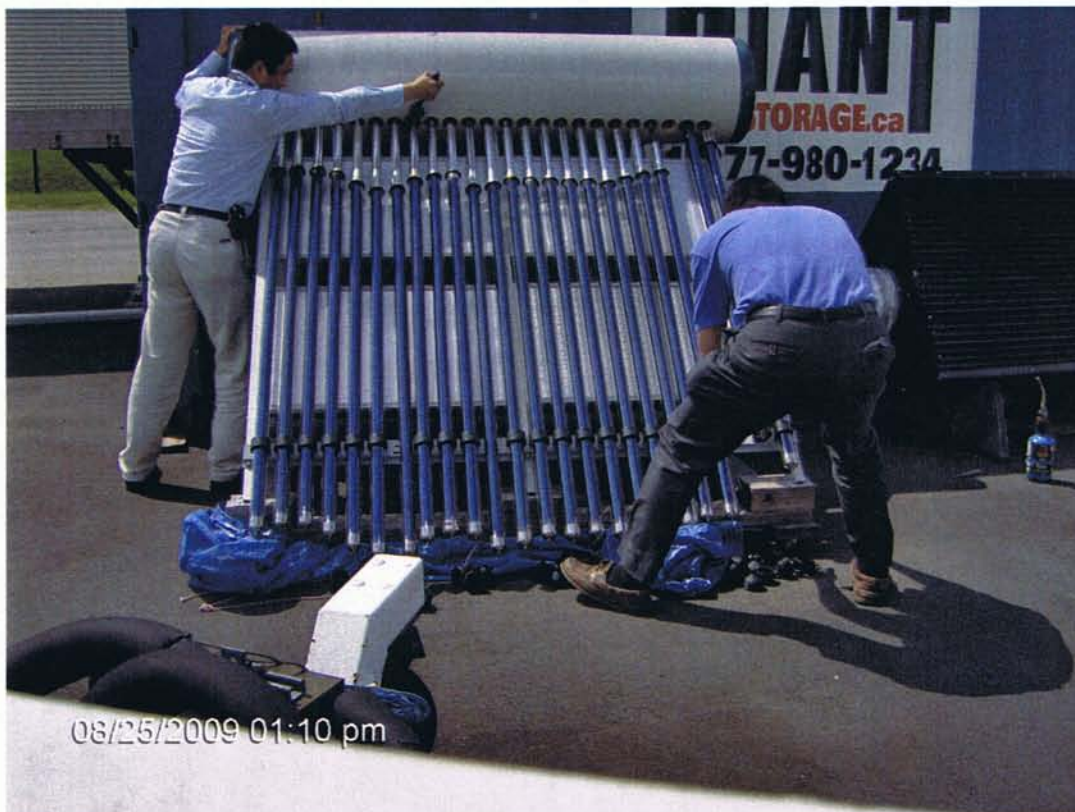
The one O-ring that had been damaged during removal was replaced with a new O-ring. All the heat pipes were then checked for tightness. All heat pipes were found to be too loose; some were able to be turned by hand, and some could not be turned by hand, but could easily be turned using a wrench. All heat pipes were then tightened, leaving the original, weathered O-rings still in place.

Figure 2: Tightening heat pipe connections to the tank, leaving the original, weathered, O-rings in place.

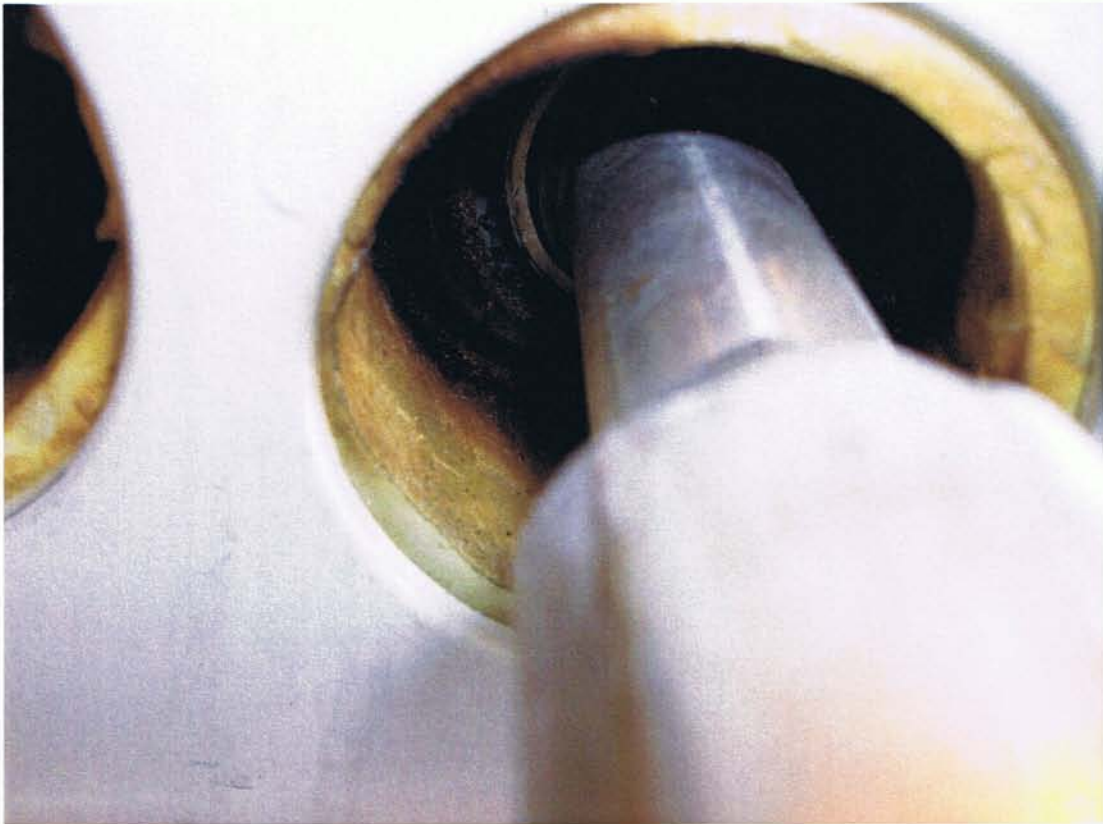
During the removal of the evacuated tubes to expose the heat pipes, an inspection was made of the insulation surrounding the heat pipe connections with the tank. Discoloration of the foam insulation was observed. Typical condition of the insulation is shown in Figure 3 and in Appendix A.

Figure 3: Discoloration of the foam insulation after outdoor exposure.

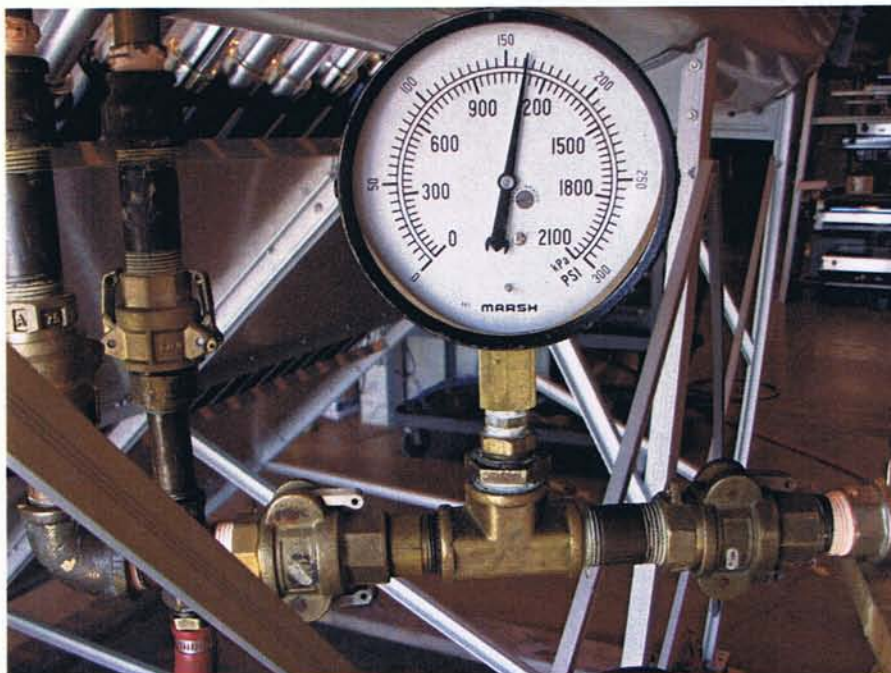
Equipment used: Pressure gauge MII# B01323
No visible leaks after collector had been pressurized for 10 minutes at 161psi

Figure 4: View of pressure gauge after the 10 minute collector pressure test.

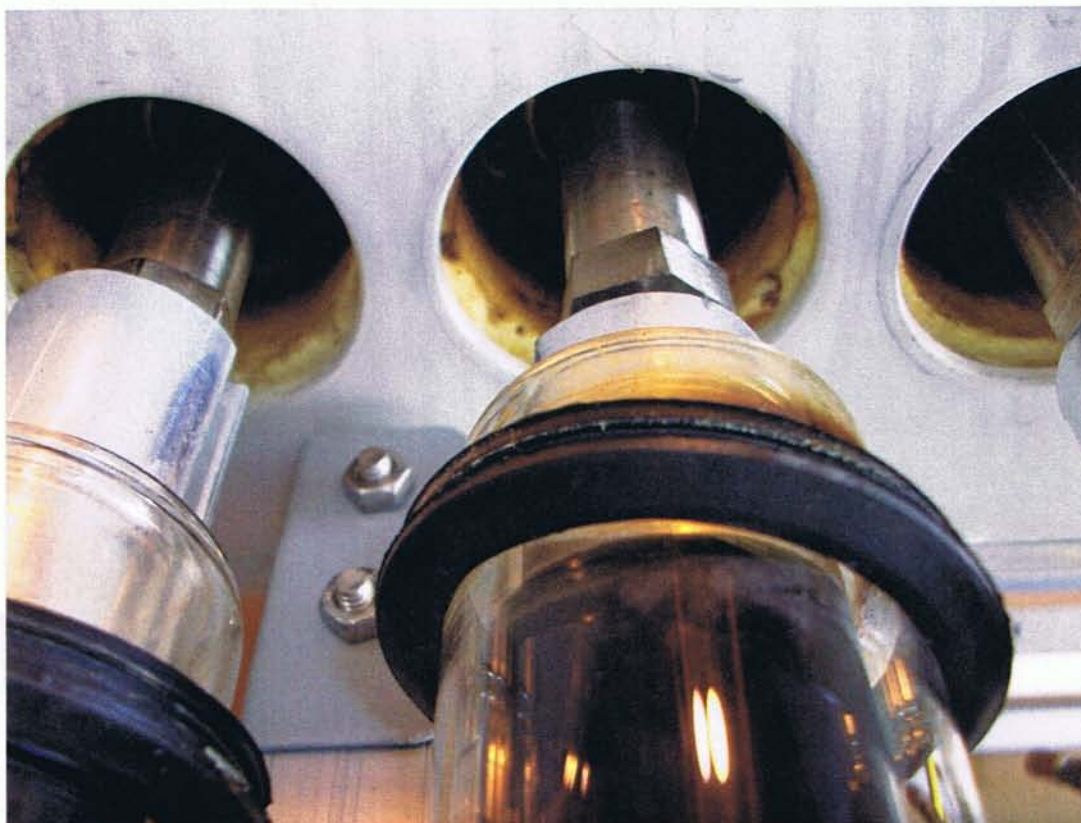
Figure 5: Tubes pulled out of tank to tighten heat pipes securely.

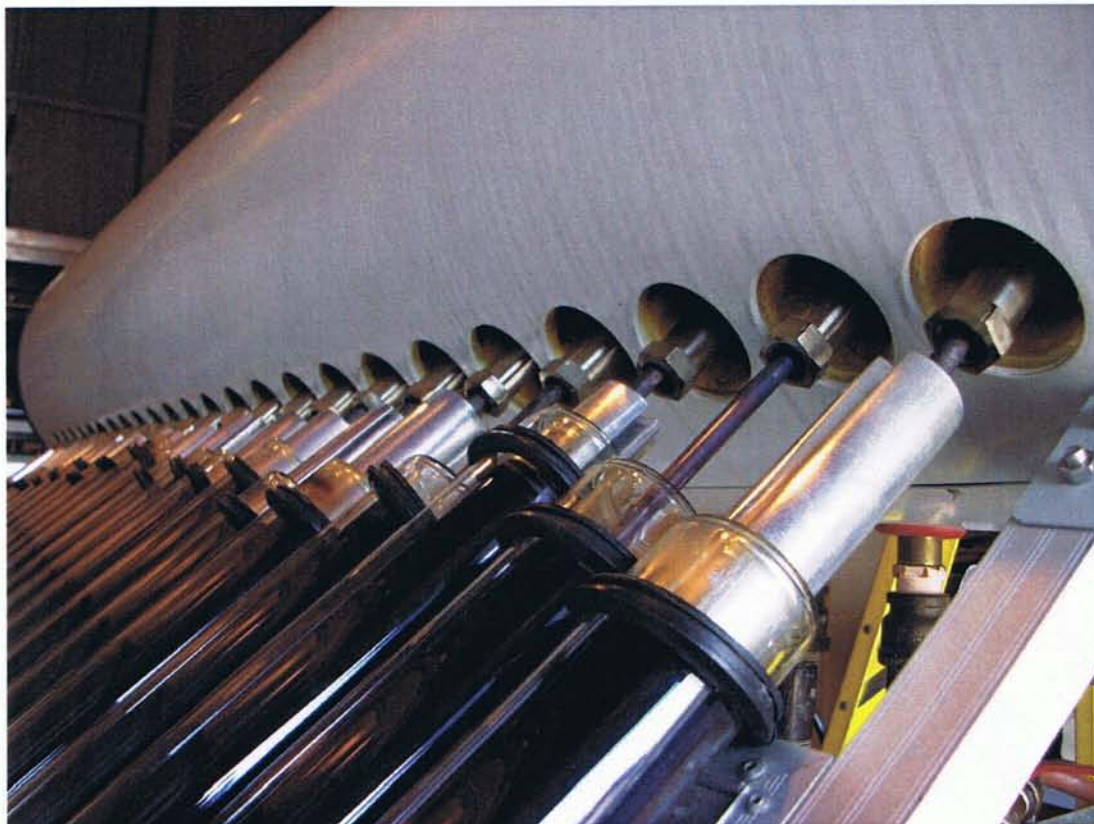
Figure 6: View of the tank and tubes after heat pipe inspection.
